SF521

**Subject: Replacing entrance door manual operation label**

**Models Affected: Minotour SRW, DRW**  
**Build Dates: May 1, 2002- January 11,2016**

# Field Service Campaign

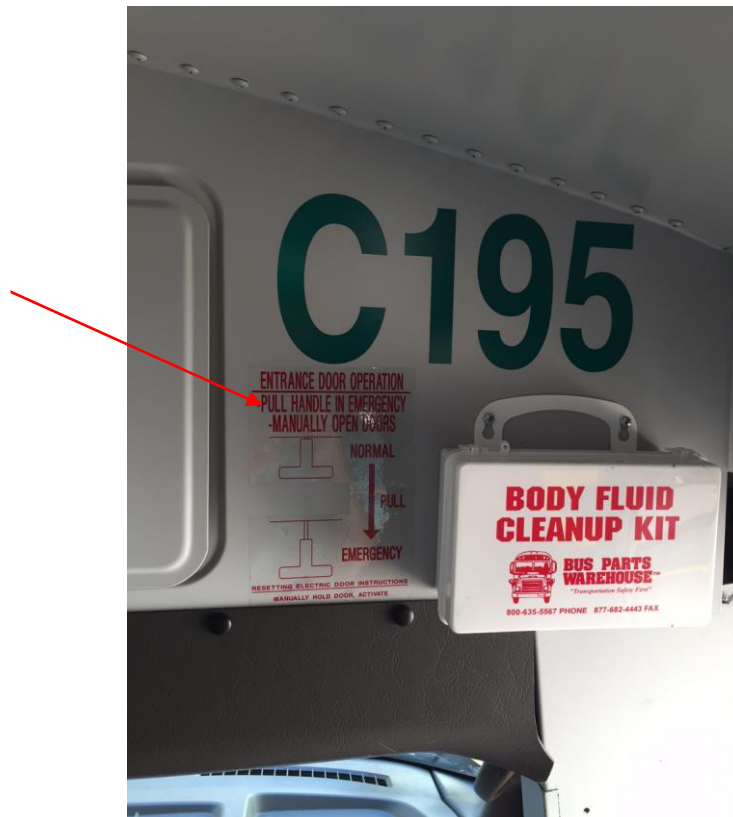
Figure 1

Remove this  
label

1. Locate the vehicle in shop bay and bring up to room temperature or locate bus where the temperature is warm so that original sticker can be removed. Cold environments make the decal removal difficult.
2. Chock wheels, set parking brake, put transmission in park/neutral and turn ignition to key off.
3. Remove the positive battery cable.
4. Locate current label, **Figure 1**. Carefully remove the label and discard. Clean area off with alcohol or other cleaner.
