# Recall Campaign

August 2019  
FL818AB  
NHTSA #19V-444  
Transport Canada #2019-288

## Subject: TBB Bendix Air Disc Brake Calipers

**Models Affected: Specific Model Year 2010 to 2019 Thomas Built Buses Saf-T-Liner HDX, EFX, and C2 (Freightliner Custom Chassis B2 school bus chassis) buses manufactured March 16, 2009, through June 29, 2018.**

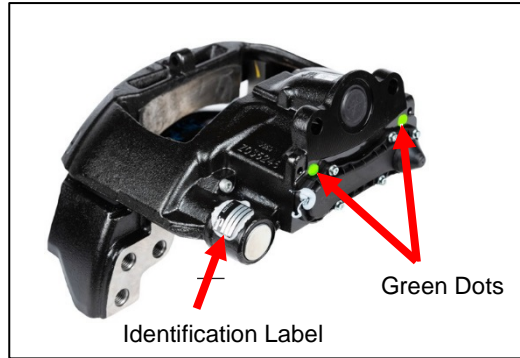
Figure 1: Locating Information on the Caliper

5. Inspect for the presence of a green dot in either location shown in **Figure 1**.  
If no green dot is present, continue with the next step.  
If a green dot is present, no further work is needed. For FCCC chassis in FL818B, clean a spot on the base label (Form WAR259). Write the recall number, FL818, on a completion sticker (Form WAR260), and attach it to the base label to indicate this recall has been completed. For TBB buses in FL818A, the procedure is complete.

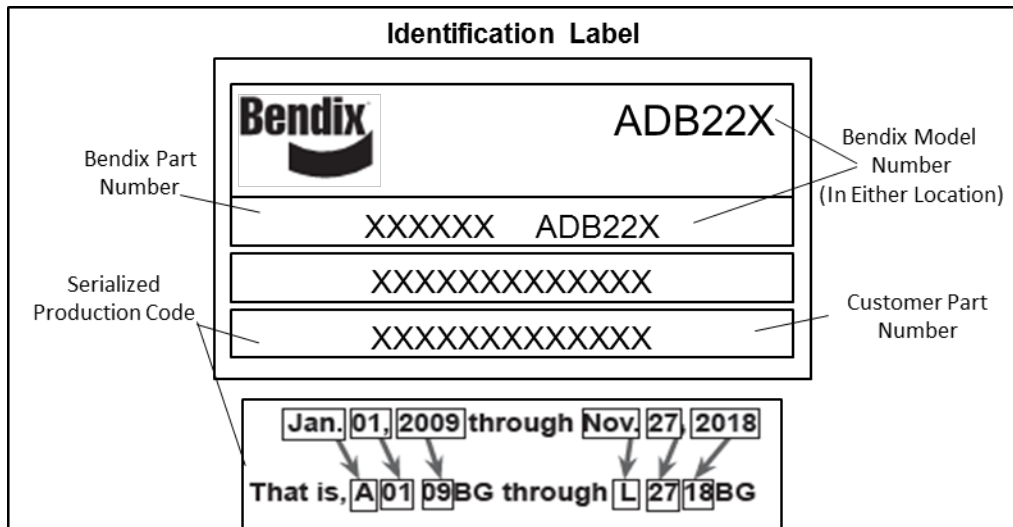
Figure 2: Bendix Label and Date Code Range

6. Inspect the identification label on the caliper. (Remove paint coating if necessary.) See **Figures 1, 2, and 3**.  
If the manufacturing date code is January 2, 2009, through November 27, 2018, replace the caliper. The majority of buses will require a caliper replacement.  
If the manufacturing date code is **not** in the specified date range no further work is needed. For FCCC chassis in FL818B, clean a spot on the base label (Form WAR259), write the recall number, FL818, on a red completion sticker, and attach it to the base label. For TBB buses in FL818A, the procedure is complete.
