December 2023
FL973 A-D
NHTSA #23V-333
Transport Canada #2023-276

Subject: TBB C2 Interior Side Sheet Joint

**Models Affected: Specific model years 2021-2024 Thomas Built
Buses Saf-T-Liner C2 school buses manufactured
January 24, 2020,through April 18, 2023.**

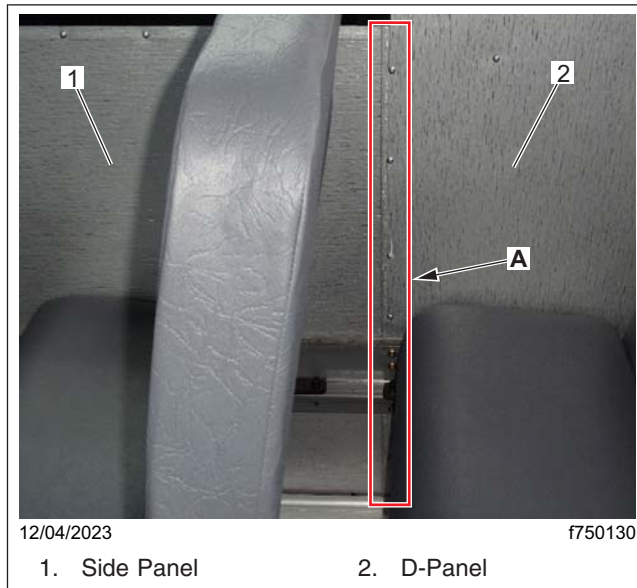
Fig. 2, Location of the Lap Joint

5. To identify the correct installation location for the new fasteners, locate the rear interior joint formed when the D-panel overlaps with the side-sheet at the last rafter as shown in **Fig. 2**, and mark the fastener locations as follows.

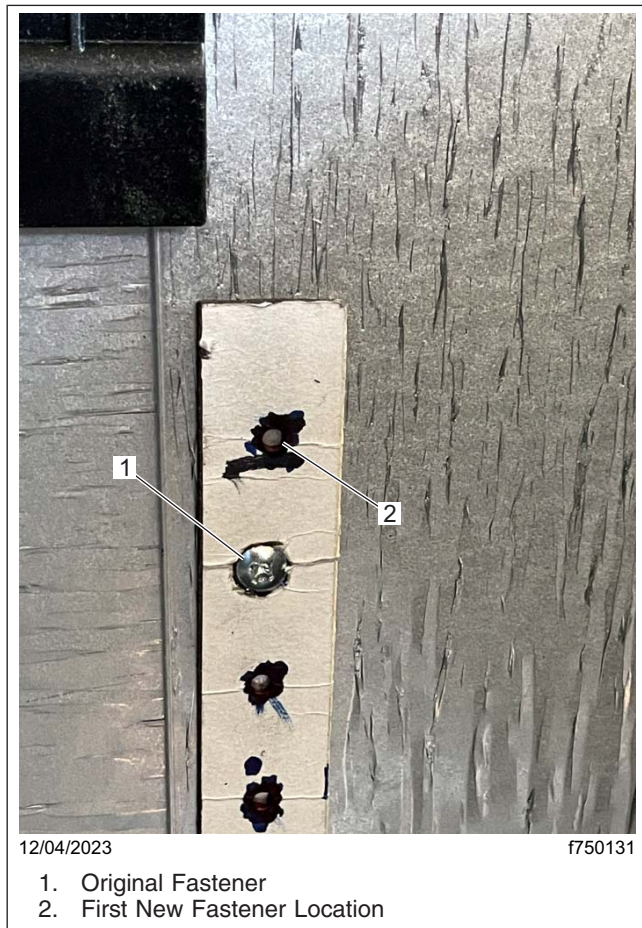
Fig. 3, Overlapped Joint Factory Original Fastener

5.1 For the first new fastener location, locate the original factory fastener in the joint, and measure 1-1/8 inch upward, as shown in **Fig. 3**.

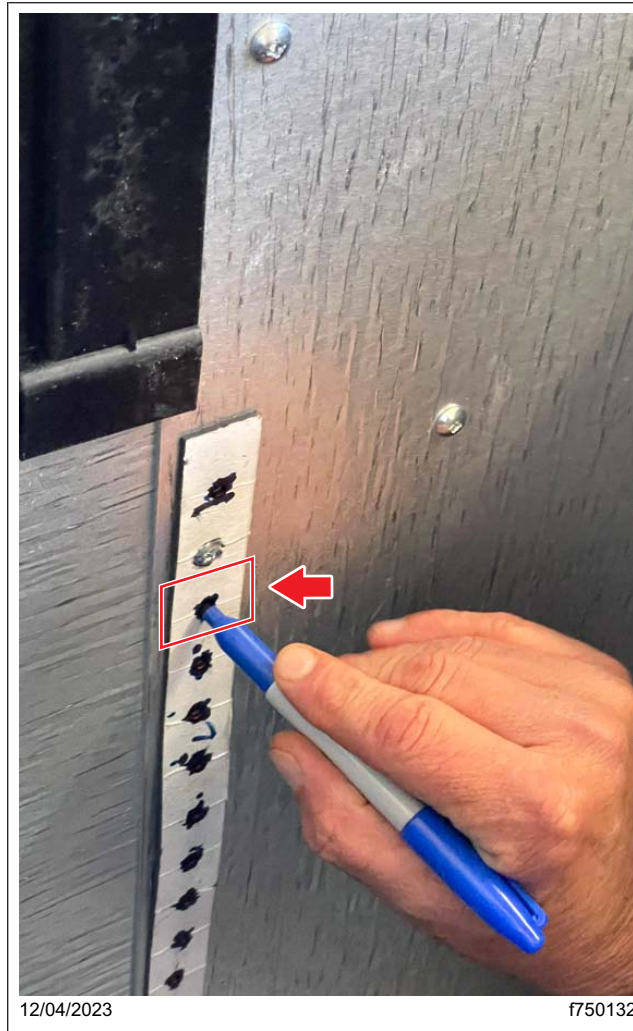
Fig. 4, Location of the Second Fastener

5.2 For the second fastener location, measure 1-3/16 inch downward from the original fastener. See [Fig. 4](#).

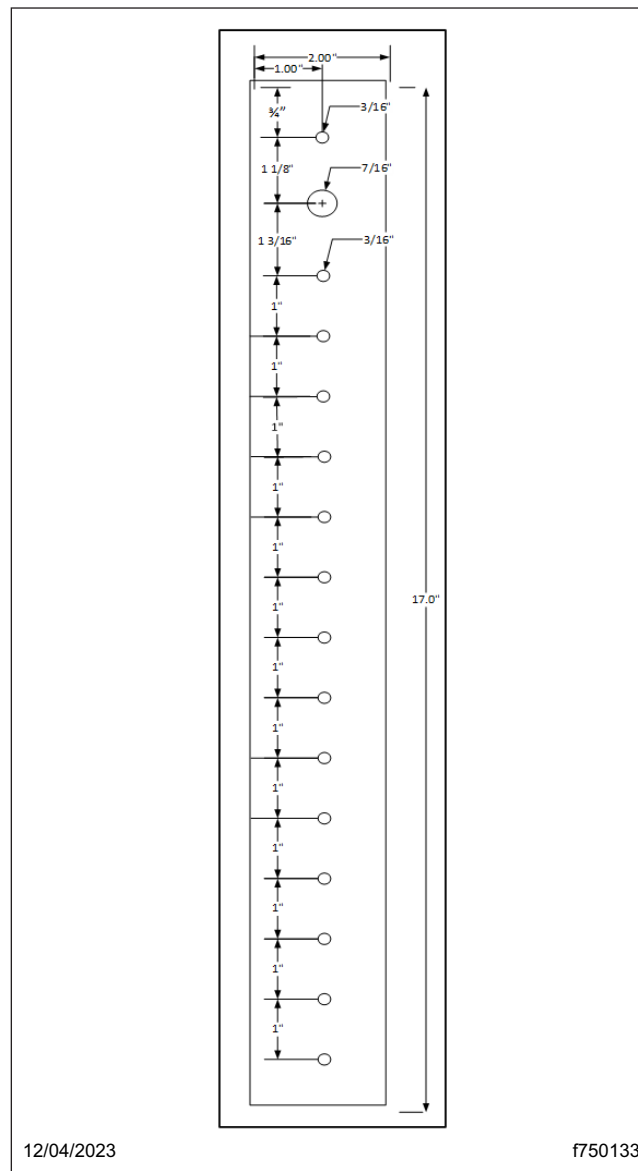
Fig. 5, Fastener Template

- 5.3 For the third and subsequent fasteners, continue to measure 1 inch downward from the second fastener for a total of 13 fasteners as shown in **Fig. 5**.

6. Use a 1/8-inch (#19) drill bit to pre-drill a hole at each location identified in the previous step.
7. Install the fastener from kit (TBB 69003099) in each pre-drilled hole.
8. Remove any metal chips, and clean the surface with a clean cloth.
9. Install the bottom seat cushion.
10. Connect the negative battery cables to the battery.
11. Turn the MPDS to the ON position.
