July 2019
FL757A-N
Transport Canada #17-581 (Non-School Buses)
Transport Canada #17-582 (School Buses)

Subject: ICU3S Instrument Cluster Hydraulic Brake Telltale

Models Affected: Specific Freightliner Business Class M2 vehicles and Freightliner Custom Chassis S2C bus and B2 school bus (Thomas Built Buses Saf-T-Liner C2) chassis manufactured March 2, 2015, through October 23, 2017.

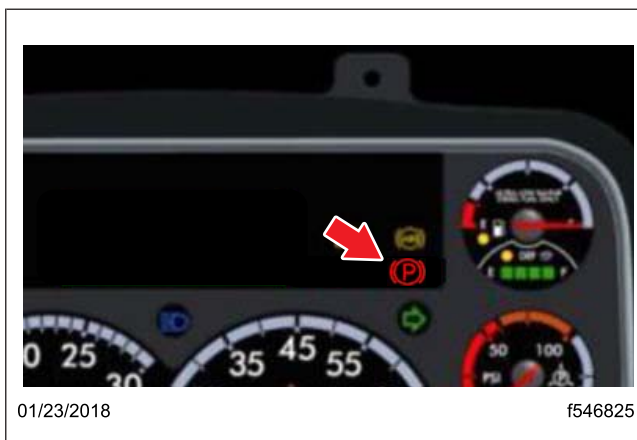
Fig. 1, A Parking Brake Applied - Replace ICU3S

1. Check the base label (Form WAR259) for a completion sticker for FL757 (Form WAR260) indicating this work has been completed. The base label is usually located on the passenger-side door, about 12 inches (30 cm) below the door latch (trucks) or over the driver's window (buses). If a completion sticker is present, no work is needed. If a completion sticker is not present, proceed to the next step.
2. Park the vehicle, shut down the engine, and apply the parking brakes. Chock tires.
3. During the bulb check at key-on, inspect the telltales on the ICU3S (affected telltales will be illuminated for three seconds). See [Fig. 1](#) and [Fig. 2](#).

If the ICU3S displays a "parking brake applied" ISO symbol, continue with the next step.

4. Attach a sticker to the driver side door frame indicating the mileage from the driver display and the date the ICU is being replaced.

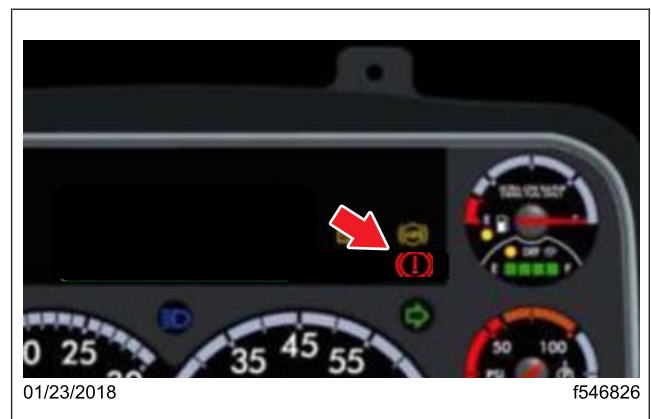
Fig. 2, A Brake Malfunction - OK, No Replacement

If the ICU3S displays a "brake malfunction" ISO symbol, no further work is needed. Clean a spot on the base label (Form WAR259), write the recall number, FL757, on a red completion sticker (Form WAR260), and attach it to the base label.

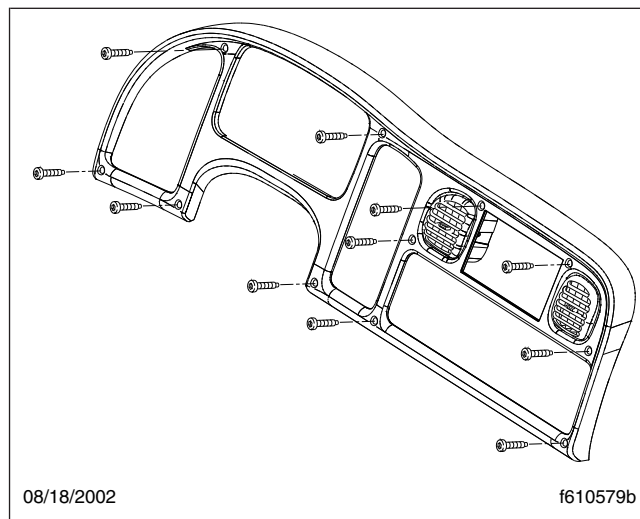
Fig. 3, Dash Trim Piece

6. Discharge the air pressure from the primary and secondary air tanks.
7. Remove the dash trim piece by removing the eleven screws that secure it. All fasteners for this procedure are 10–16 Torx® capscrews. See [Fig. 3](#).

15. Install the dash trim piece and secure it with eleven capscrews. Tighten the capscrews 30 lbf-in (340 N·cm).
 16. Connect the batteries.
- NOTE: Mechanical (air) gauges do not make a sweep.

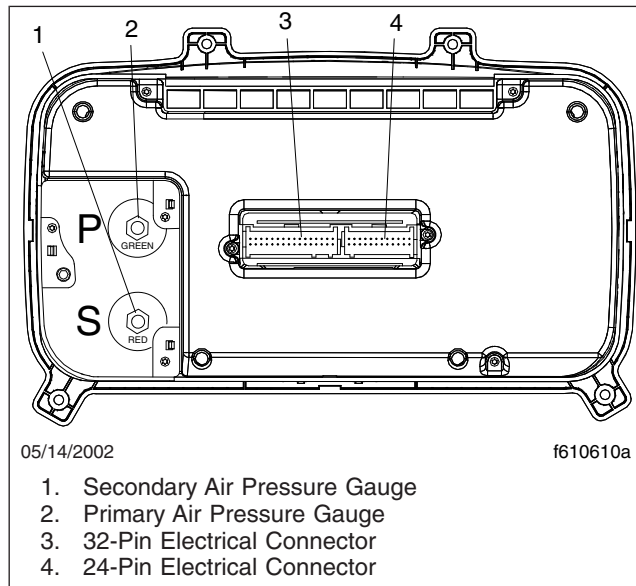
Fig. 4, ICU3, Rear View

8. Remove the four screws that secure the ICU.
9. Disconnect the two electrical connectors from the back of the ICU. See [Fig. 4](#).

10. Remove the air lines by pressing the push-lock connectors, then pulling the air lines away from the gauges. The lines are color-coded for ease of installation. The primary air line is green and is connected to the upper gauge. The secondary air line is red and is connected to the lower gauge.

11. Remove the two telltale carriers (cartridges) from the old ICU, making sure to pay attention to their orientation. Install the carriers on the new ICU. Make sure that the left and right carriers remain on the same sides as they were removed and that the arrow on the top is facing the same side as the display.

12. Connect the air lines to the air gauges to the new ICU3S by pressing them firmly into the push-lock connector on the back of the gauge. The green air line connects to the primary (upper) gauge. The red air line connects to the secondary (lower) gauge.

13. Connect the electrical connectors to the back of the ICU3S.
 14. Place the ICU3S in the dash opening and secure it with the four capscrews. Tighten the capscrews 30 lbf-in (340 N·cm).
