Recall Campaign

Daimler Trucks
North America LLC

Subject: TBB SMI Prolo Roof Hatches

Models Affected: Specific Model Year 2019-2020 Thomas Built Buses Minotour and Saf-T-Liner C2, EFX, and HDX model buses manufactured September 10, 2018, through June 26, 2019, with certain Specialty Manufacturing Prolo 924X Series Roof Escape Hatches manufactured August 1, 2018, through May 20, 2019.

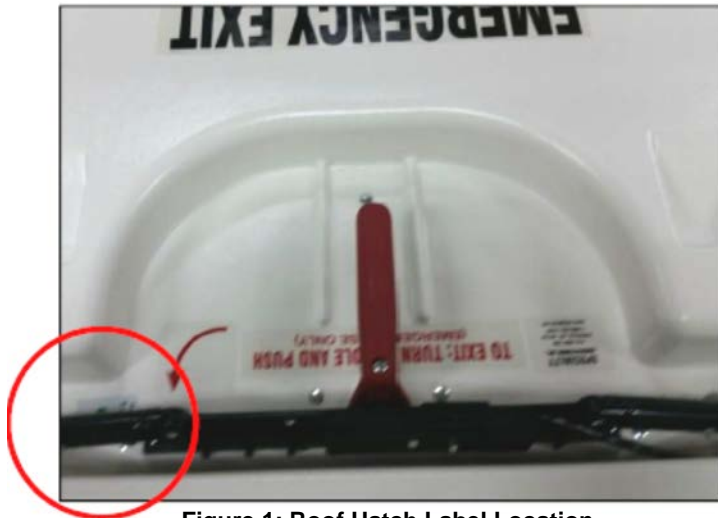
Figure 1: Roof Hatch Label Location

1. Park the vehicle on a level surface, shut down the engine, place the bus in Park, and set the parking brake. Chock the tires.
2. Locate the silver label on the bottom of the Prolo hatch (inside the bus). There may be more than one Prolo roof hatch, inspect all hatches. See **Figure 1**.
3. Confirm the part number. See **Figure 2** for part number location. The affected part number format is: "92XX-XXXXX."

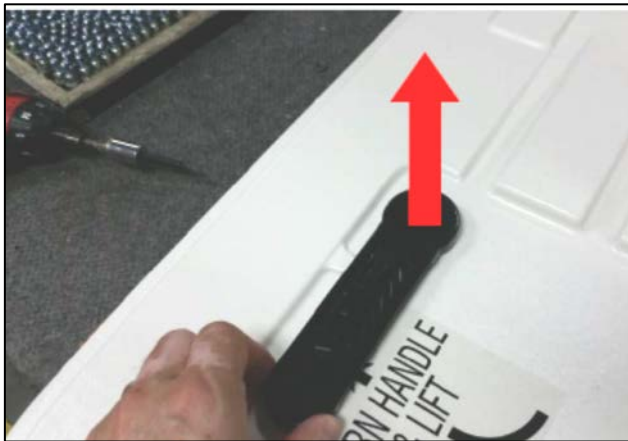
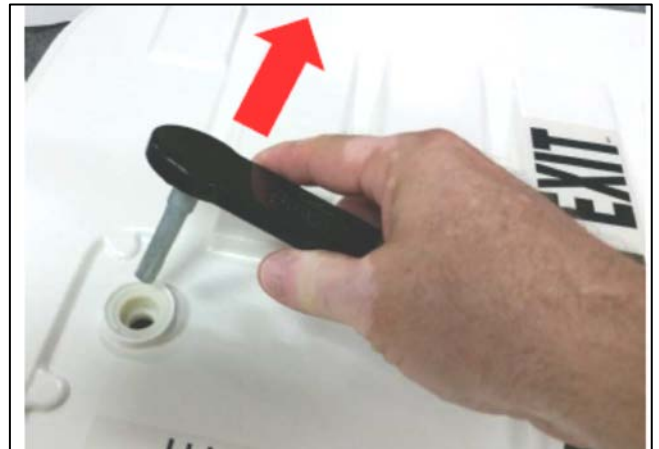
Figure 4: Removing the Exterior Hatch Handle

2. Open the hatch 5-6 inches and pull the black exterior handle from the bushing. See **Figure 4**.

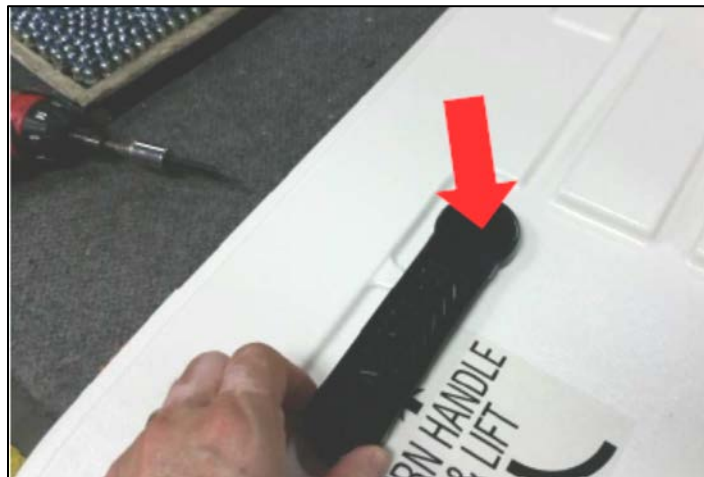
Figure 5: New Handle Inserted in the Hatch

3. Discard any existing O-ring on the bushing and secure the new O-ring from the kit around the base of the stem of the new black handle.
4. Insert the shaft of the new handle into the bushing, oriented as shown in **Figure 5**.

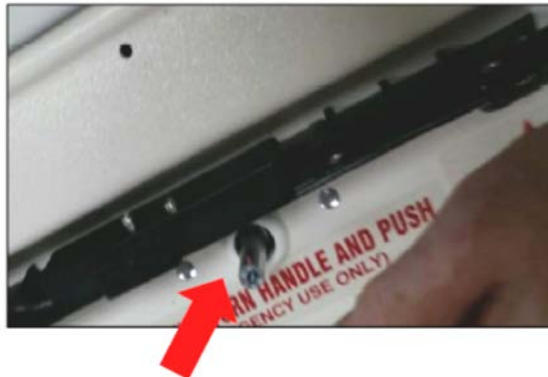
Figure 6: Handle Stem through the Interior of the Hatch

5. From inside the lid, locate the shaft of the outer handle. See **Figure 6**.

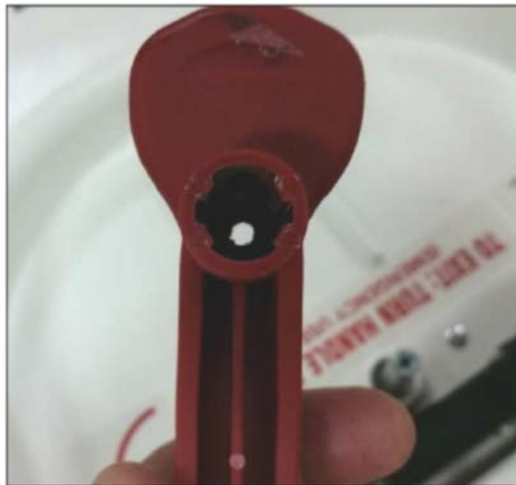
Figure 7: Ribs Inside the Red Interior Handle that Self-Orient

6. The red handle, removed earlier, has ribs to self-orient the handle when reinstalled with the black handle. See **Figure 7**.

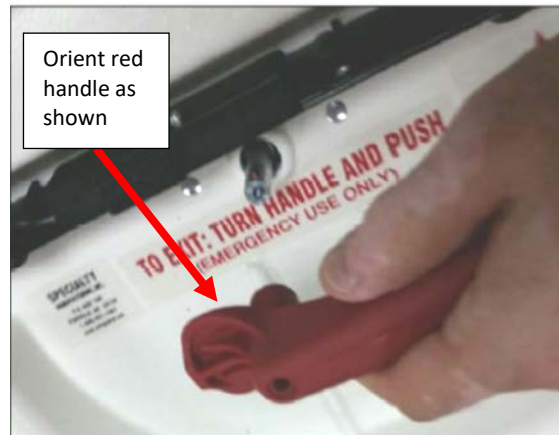
Figure 8: Installing the Red Handle on the Interior of the Hatch

- From inside the bus, place the red handle on the stem of the external handle. Orient as shown in **Figure 8**.

- Install the screw from the kit using a drill or 1/8-inch Allen wrench. Tighten to 10-12 lbf-in.
- Once the red handle is installed, confirm the micro switch is mounted to the black mounting bracket the red handle activates. The switch activates when the handle is oriented at 90 degrees to the bracket.
- Secure the lid to the trim subassembly by rotating the inside (red) handle into position. There should be a “click” when the switch is activated. If this does not occur, replace the switch.
- Place a green sticker on silver label on the bottom of the Prolo hatch (from inside the bus). See **Figure 9**.
