REF #: ICI17-019
Effective: 08/03/2017
Release: 08/09/2017

SUBJECT: TBB Maintenance Guidelines for Electrical Power Distribution Centers

Subject: Maintenance Guidelines for Electrical Power Distribution Center (PC Board Configuration)

MVP-ER, HDX, ER, MVP-EF, FS65

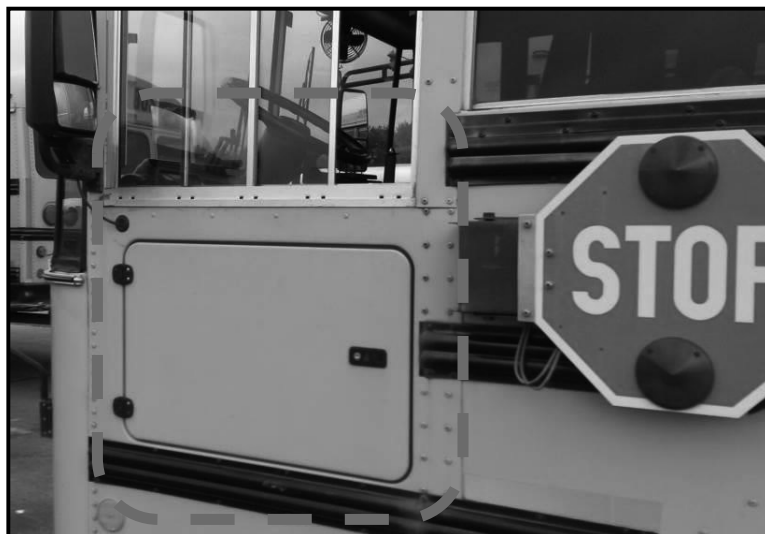
Figure 1: Overview example of exterior electrical cabinet door and driver's window

Do not power wash or steam clean the door of Electrical Power Distribution Center. Power washing/ steam cleaning near the Electrical Power Distribution Center may permanently damage components which could result in fire, personal injury, or property damage. The driver's window must remain closed at any time there is water exposure. Do not place any liquid container above, on, or inside switch cabinet.

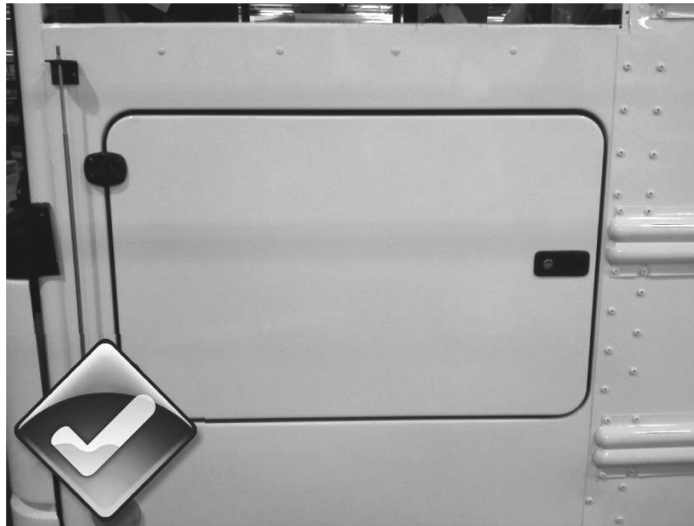
Figure 2: Acceptable - Door is parallel with panel opening. Latch draws gasket tight against body panel.

1. Do not expose PC boards or other electrical components to water or moisture. Take the following actions to prevent water exposure:
 - a) Check the exterior panel door and gasket for proper closure and sealing. The gasket should be evenly installed around the door perimeter and the door should align with the panel opening. Check for broken door gasket. The door should close and latch fully. Adjust latch and pull to ensure a tight closure. Do not loosen latch to enable ease of access.

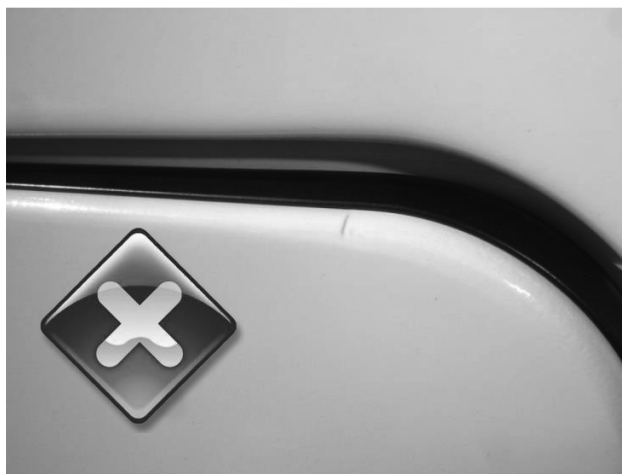
Figure 3: Unacceptable - Door is bent and does not close fully.

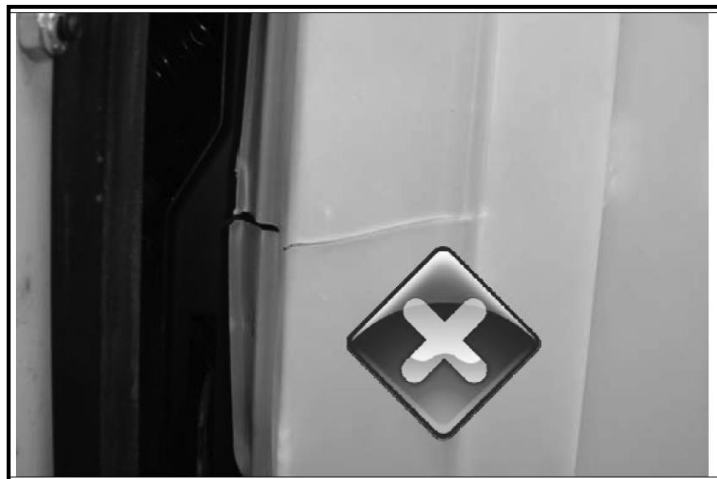
Figure 5: Unacceptable - Cracked PC board cover may result in water intrusion

- c) Ensure PC board covers do not have cracks or other damage.

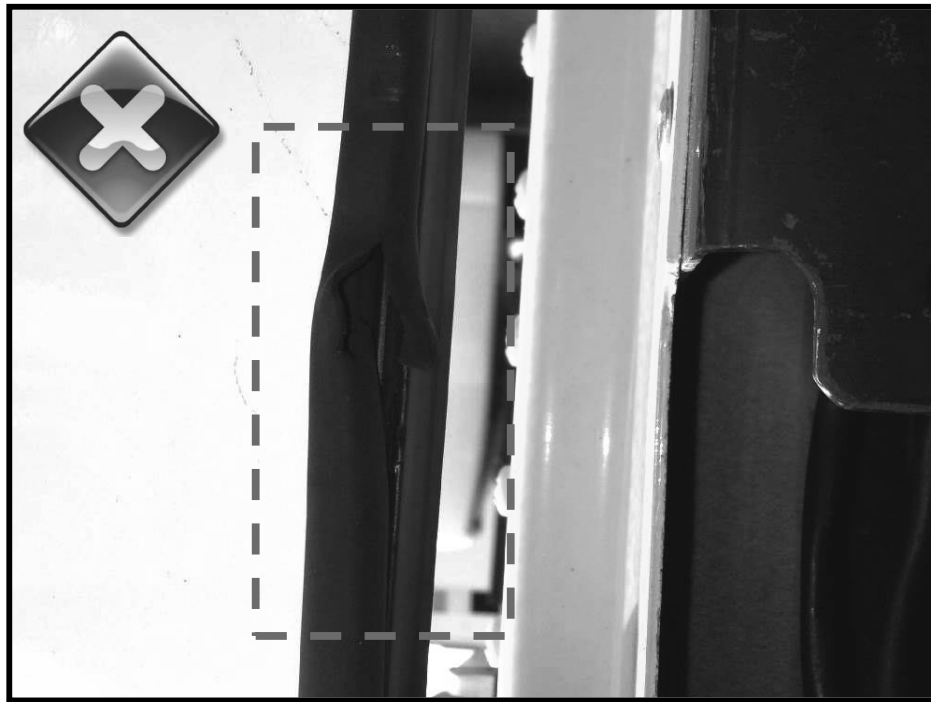
- d) Inspect the electrical door seal, PC boards and other electrical components to ensure they are dry and in full working condition.

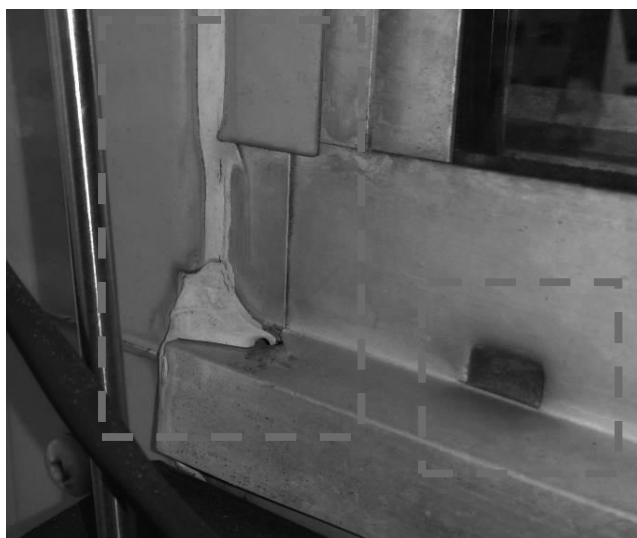
Figure 6 and 7: Unacceptable - Cracked and dry old caulk and drain holes needing repairing

- e) Inspect driver's window. Make sure that felt seal is sealing properly. Clean drain troughs, to ensure adequate drainage. Reapply new caulk if cracked or degraded.

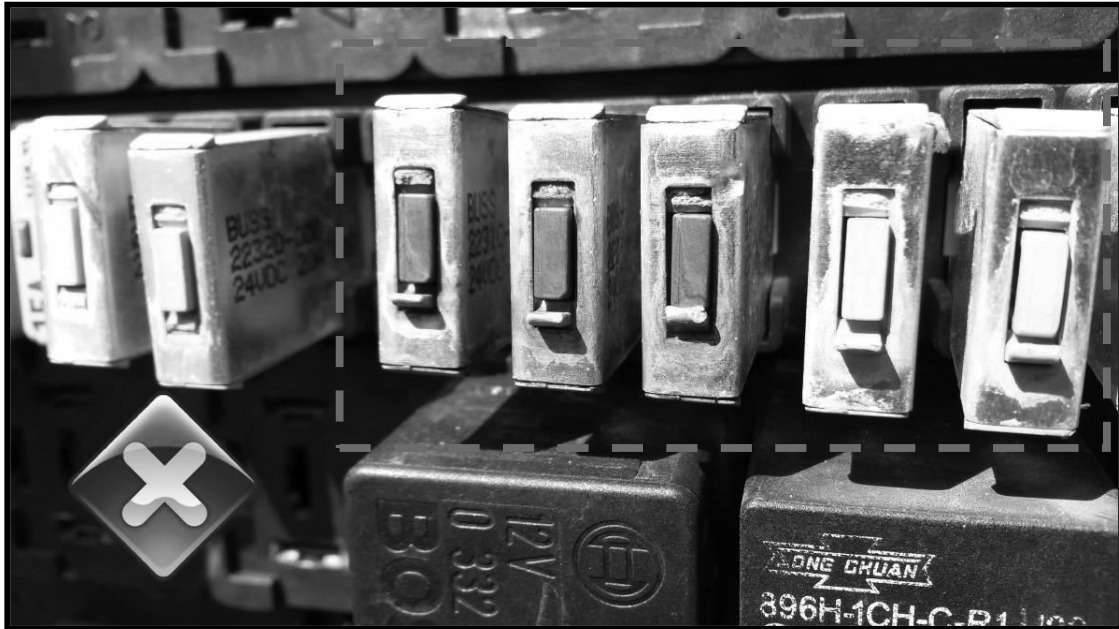
- f) Inspect PC boards and internal components at the inspection interval for signs of water exposure. Water draining from the bottom of the electrical panel door after a rain or bus wash may indicate water intrusion. Water intrusion into the electrical cabinet can cause corrosion on the electrical devices. All electrical devices showing signs of corrosion must be replaced.

Figure: 8, 9 and 10: Unacceptable - Examples of corrosion that need to be addressed with new components.

- g) When a power distribution board is replaced the addition of DTNA recommended dielectric grease must be added to the wire hardness sockets, relay sockets, and fuse slots. Reference DTNA Engineering Standard 48-02439 for approved dielectric greases.
- h) The ring terminal electrical cables connected to the power distribution board power studs must be secured with nylon locknuts torqued to 65in-lbs (+/- 2in-lbs).

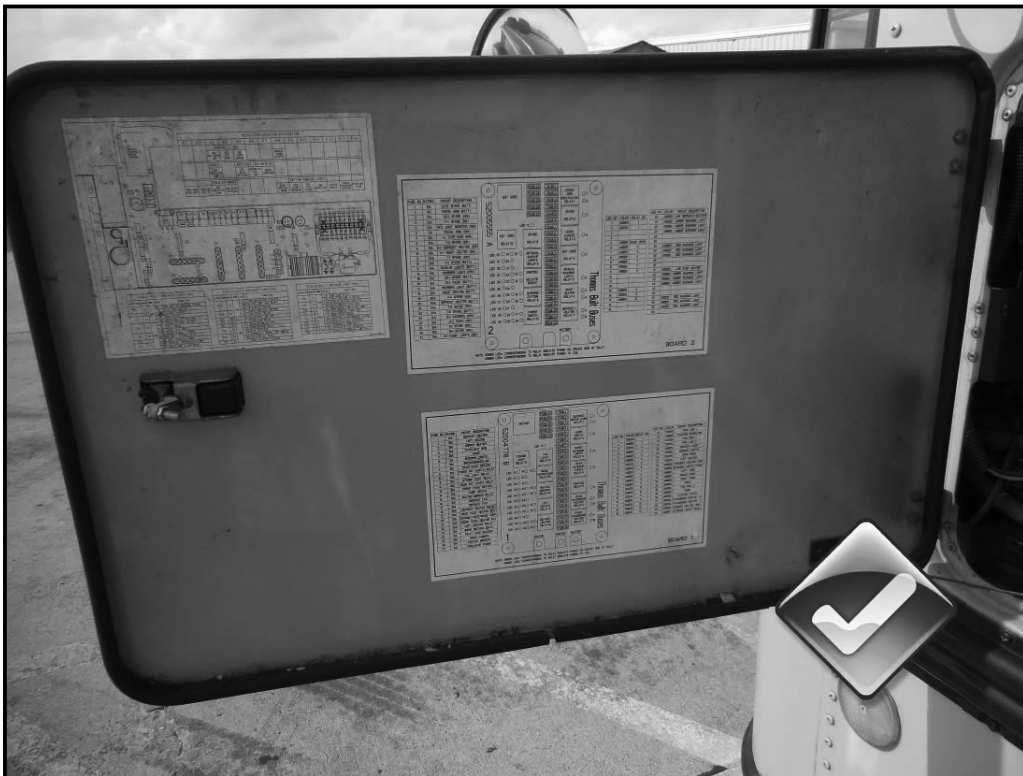
Figure: 12: Acceptable - Example of Fusing labeling on inside of Electrical Panel Door.

2. The fuses or manual circuit breakers rating, installed into the power distribution boards, must match the rating specified by the supplied label located on the external side electrical cabinet door or service manual.

Fuse and manual breaker ratings **MUST NOT** exceed the specified design rating.

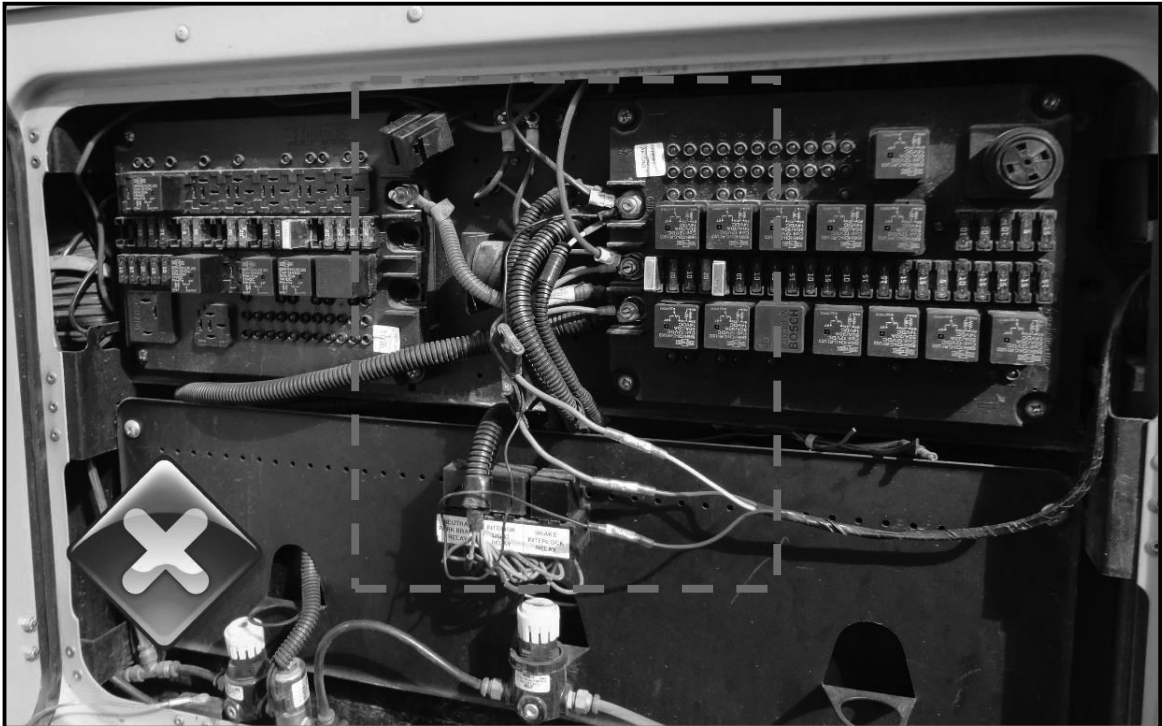
Figure 17: Unacceptable - Add-on connections attached to the power, ignition, and ground studs.

1. Do not obtain power, ignition, and ground from the electrical distribution board lug terminals. Do not modify or source power from the electrical power distribution center for any reason including aftermarket add-ons that include but are not limited to: CB radios, Surveillance systems, Power inverters, and any other Non-OEM electrical devices.

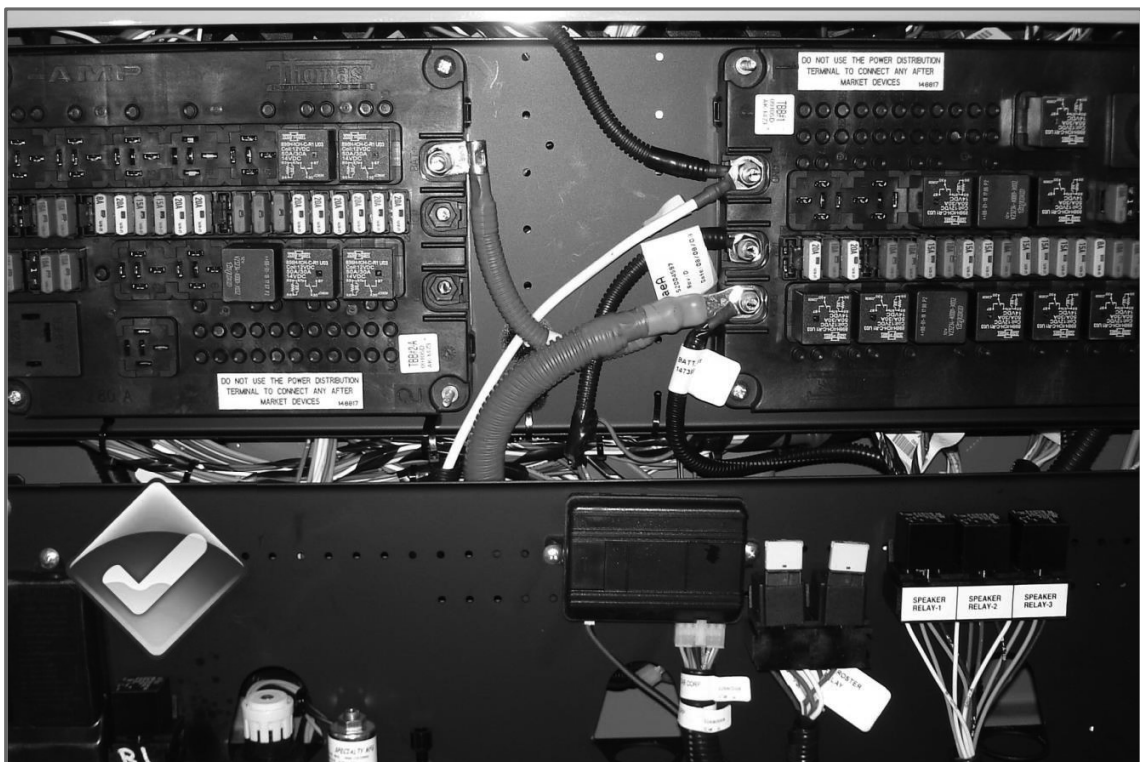
Figure 18: Acceptable - Example of proper OEM electrical connections without Add-on connections.
