# Recall Campaign

August 2019  
FL818AB  
NHTSA #19V-444  
Transport Canada #2019-288

## Subject: TBB Bendix Air Disc Brake Calipers

**Models Affected: Specific Model Year 2010 to 2019 Thomas Built Buses Saf-T-Liner HDX, EFX, and C2 (Freightliner Custom Chassis B2 school bus chassis) buses manufactured March 16, 2009, through June 29, 2018.**

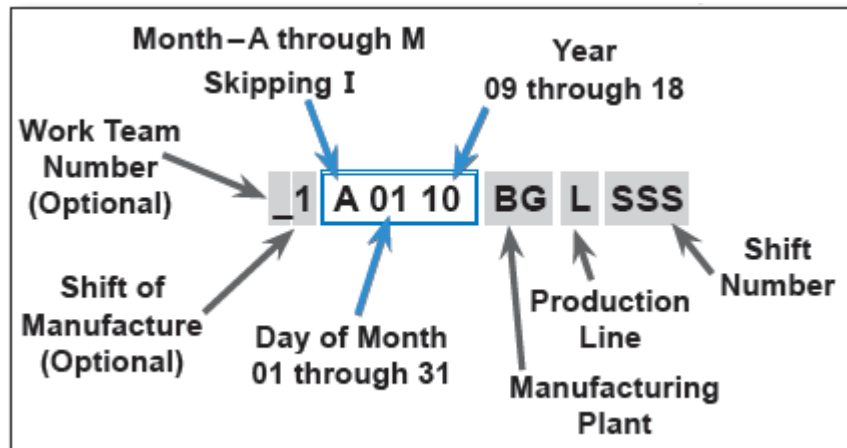
Figure 3: Key to Reading the Date Code

6. Inspect the identification label on the caliper. (Remove paint coating if necessary.) See **Figures 1, 2, and 3**.  
If the manufacturing date code is January 2, 2009, through November 27, 2018, replace the caliper. The majority of buses will require a caliper replacement.  
If the manufacturing date code is **not** in the specified date range no further work is needed. For FCCC chassis in FL818B, clean a spot on the base label (Form WAR259), write the recall number, FL818, on a red completion sticker, and attach it to the base label. For TBB buses in FL818A, the procedure is complete.
