F1011 AB

Subject: GHG Label Emissions Recall

PROBLEM:	DTNA has determined that certain MY 2022-2025 vehicles will require replacement of the GHG emission control label due to a misprint which may cause incorrect identification of the engine, resulting in customer dissatisfaction and noncompliance with the Clean Air Act.
SOLUTION:	The GHG emissions control label will be removed and replaced.

F1011 – Replacement of the Greenhouse Gas (GHG) Label

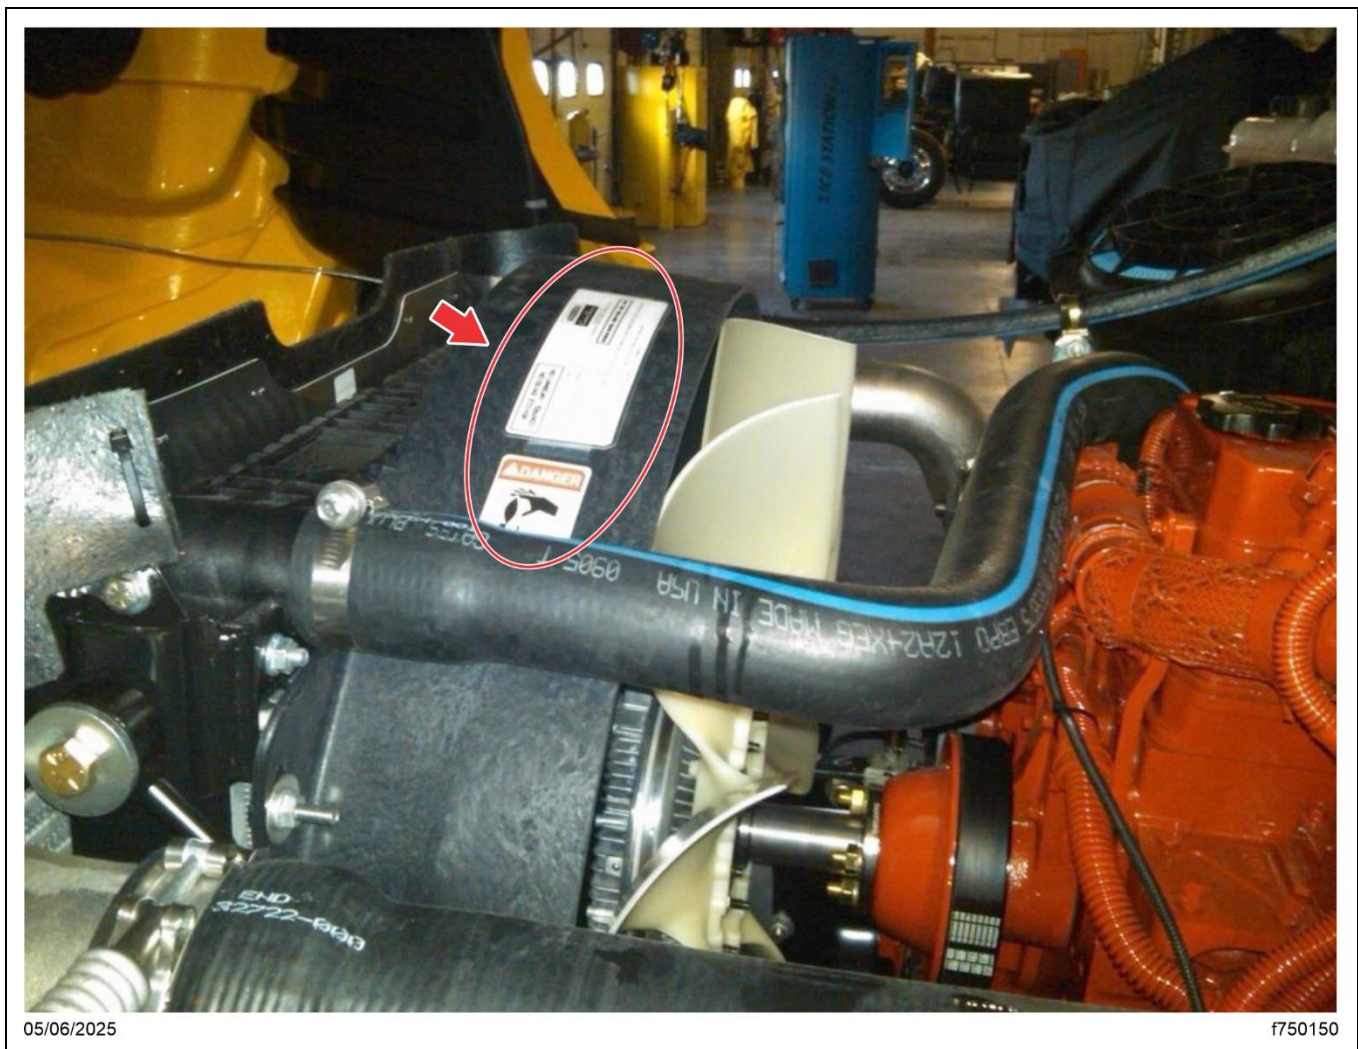
Fig. 1, GHG Label, C2/S2C

- C2/S2C applications → The label is located on the radiator fan shroud. See [Fig. 1](#).
- MT45/MT55 Chassis → The label is installed on the fan shroud, located using the measurements shown in [Fig. 2](#).
- MBC/Front Engine Motor Homes → The label is located on the driver station. See [Fig. 3](#).
- Econic SD → The label is located on the inside of the cab on the driver's side. See [Fig. 4](#).

4. Remove the existing GHG label making sure not to leave any adhesive residue. Retain the removed label for the next steps.
5. If required, clean the surface with isopropyl alcohol to remove any excess adhesive. Be careful not to cause any damage to the painted surfaces.

6. Print a copy of the CELCS, fill in all the required information, and attach the removed label to the CELCS. Attach a copy of the CELCS to the campaign claim.
7. Apply the new sticker in the same location where the old sticker was located.
8. Clean a spot on the base label (Form WAR259), and attach a campaign completion sticker for F1011 (Form WAR260), indicating this work has been completed.
